**Flood Control Project Maintenance
Levee Inspections**

Fall 2013 Levee Maintenance Deficiency Summary Report

San Joaquin River Basin

Reclamation District No. 2101 Blewett

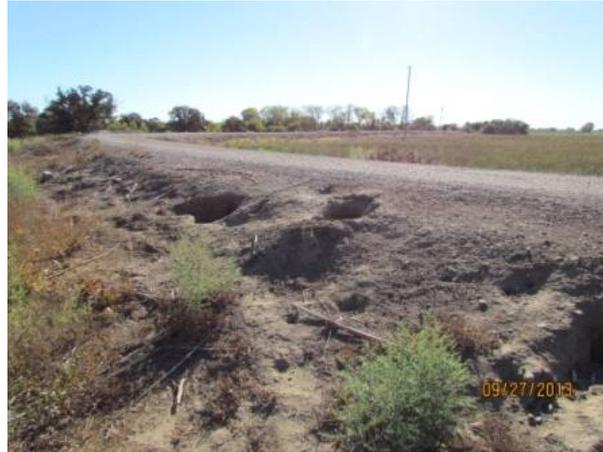
Levee Mile Report Line	4
Start Levee Mile	0.04
End Levee Mile	0.04
Location	Water Side
Category	Earthen Levee
Item	Animal Control
View of rodent holes on waterward slope, facing upstream.	
mkhashch_f_20130930_650.JPG

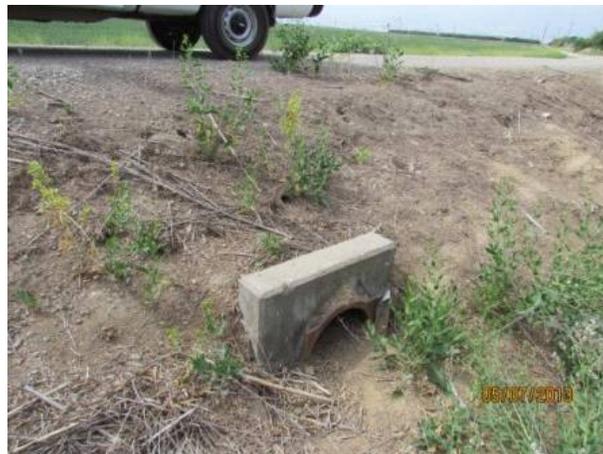
Levee Mile Report Line	5
Start Levee Mile	0.05
End Levee Mile	0.05
Location	Water Side
Category	Earthen Levee
Item	Encroachments
View of the pipe penetrating the levee. No flap gate at waterside end was observed.	
mkhashch_f_20130923_532.JPG

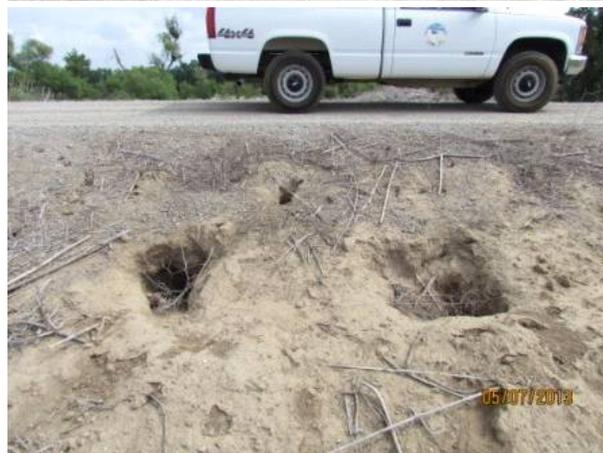
Levee Mile Report Line	6
Start Levee Mile	0.07
End Levee Mile	0.07
Location	Land Side
Category	Earthen Levee
Item	Animal Control
View of rodent burrows on the landside levee slope.	
mkhashch_f_20130923_533.JPG

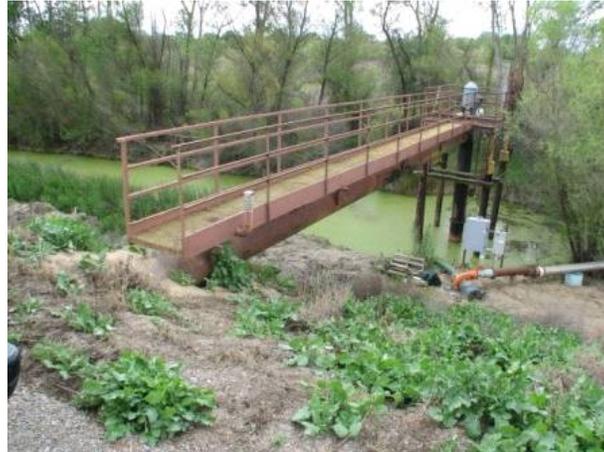
Levee Mile Report Line	8
Start Levee Mile	0.19
End Levee Mile	0.19
Location	Crown
Category	Earthen Levee
Item	Encroachments
Drainage discharge under levee crown.	
mkhashch_f_20130923_528.jpg

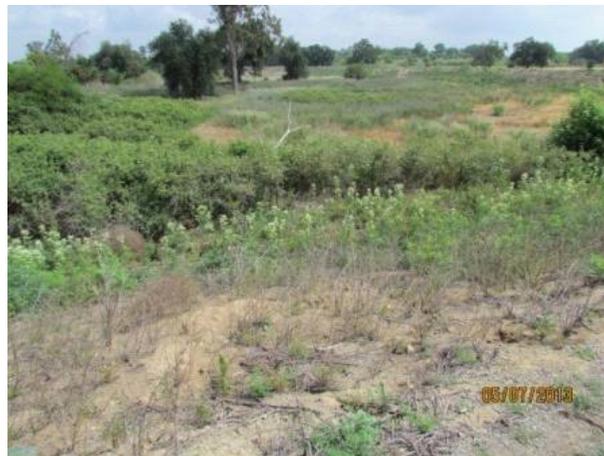
Levee Mile Report Line	10
Start Levee Mile	0.70
End Levee Mile	0.70
Location	Water Side
Category	Earthen Levee
Item	Animal Control
View of the rodent burrows on the waterside levee slope.	
mkhashch_f_20130923_547.JPG

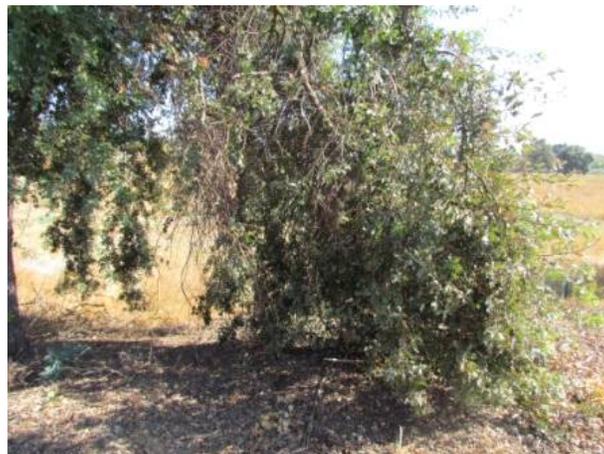
Levee Mile Report Line	11
Start Levee Mile	0.75
End Levee Mile	0.75
Location	Water Side
Category	Earthen Levee
Item	Trim / Thin Trees
View of tree branches obstructing waterside slope.	
mkhashch_f_20130923_529.JPG

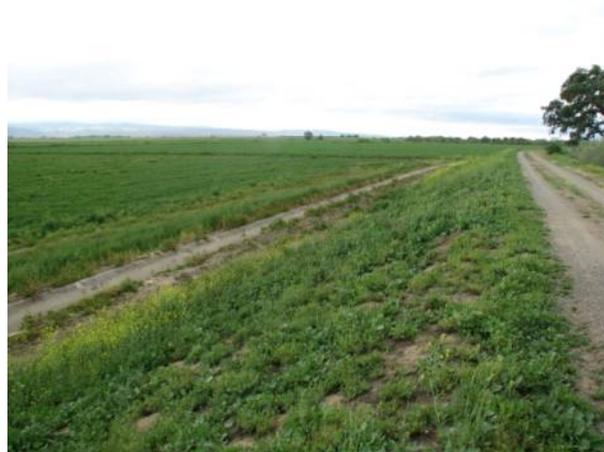
Levee Mile Report Line	12
Start Levee Mile	0.76
End Levee Mile	1.80
Location	Land Side
Category	Earthen Levee
Item	Encroachments

Concrete ditch near landside toe.

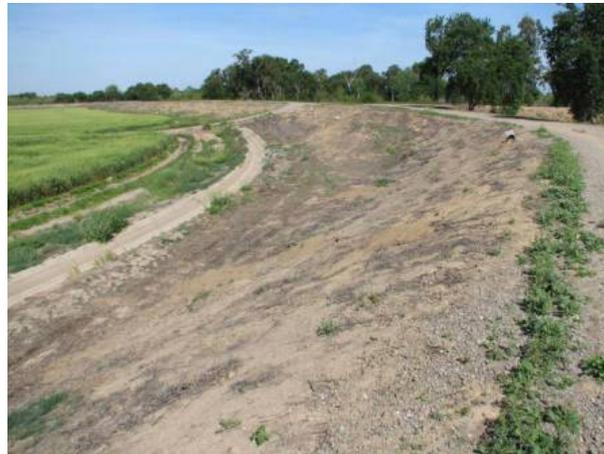
Levee Mile Report Line	13
Start Levee Mile	0.80
End Levee Mile	0.80
Location	Land Side
Category	Earthen Levee
Item	Animal Control

View of levee material removed by rodent activity on landside slope facing downstream. 05/02/2012

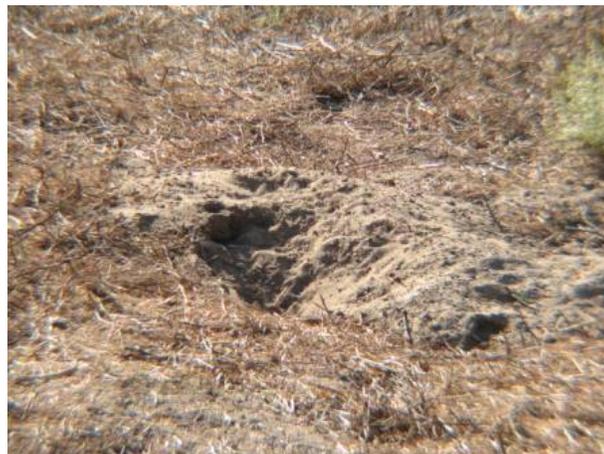
Levee Mile Report Line	14
Start Levee Mile	0.88
End Levee Mile	0.88
Location	Land Side
Category	Earthen Levee
Item	Animal Control

11/02/2011 Active rodent burrow.

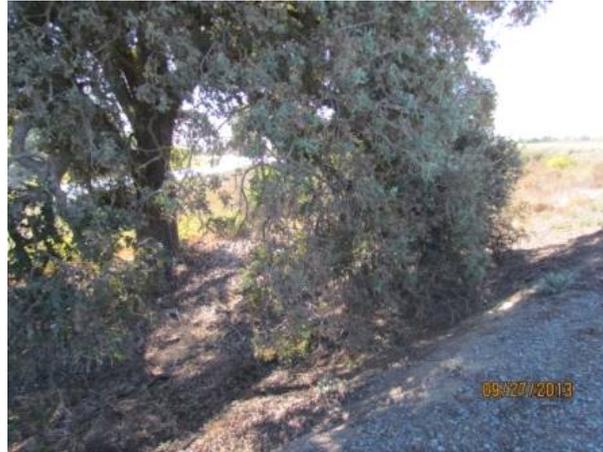
Levee Mile Report Line	15
Start Levee Mile	1.09
End Levee Mile	1.09
Location	Water Side
Category	Earthen Levee
Item	Trim / Thin Trees
View of a tree limb touching the waterside levee slope. Must be trimmed at least 5 feet away from the levee slope.	
mkhashch_f_20130930_651.JPG

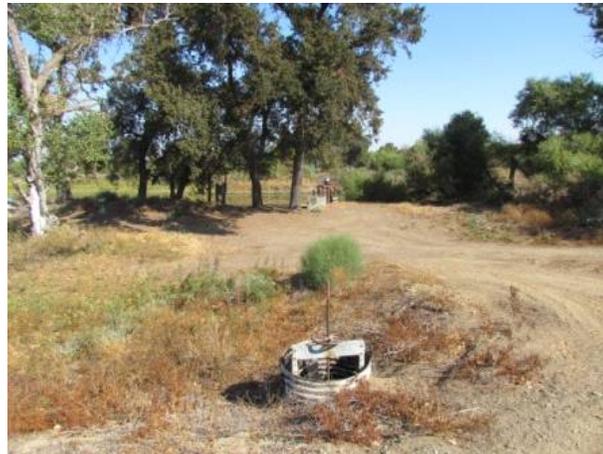
Levee Mile Report Line	17
Start Levee Mile	1.62
End Levee Mile	1.62
Location	Water Side
Category	Earthen Levee
Item	Encroachments
Photo of pump in background and CMP riser with valve in foreground.	
mkhashch_f_20130923_531.JPG

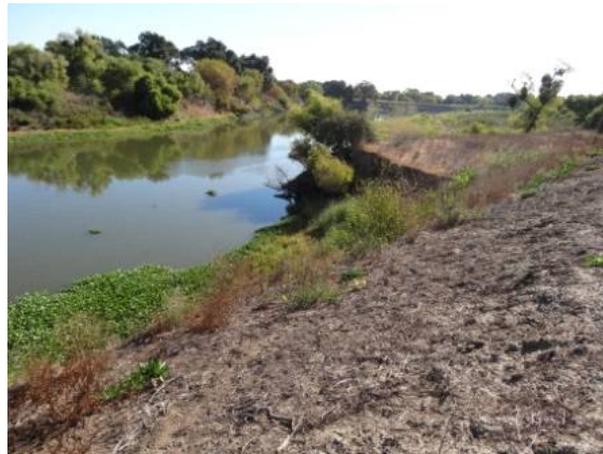
Levee Mile Report Line	18
Start Levee Mile	1.91
End Levee Mile	2.00
Location	Water Side
Category	Supplemental
Item	DWR Erosion Survey
Looking downstream of erosion.	
SJR2013_RD2101U01RM73.92_2.jpg

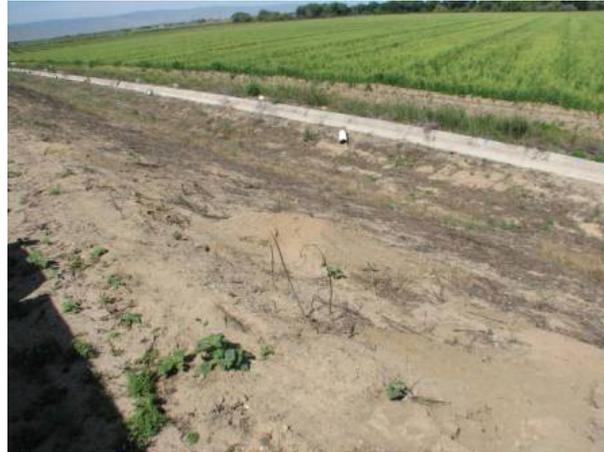
Levee Mile Report Line	19
Start Levee Mile	2.39
End Levee Mile	2.39
Location	Land Side
Category	Earthen Levee
Item	Animal Control
View of levee material removed by rodent activity on landside slope, facing upstream. 05/02/2012	
mkhashch_f_20130923_555.jpg

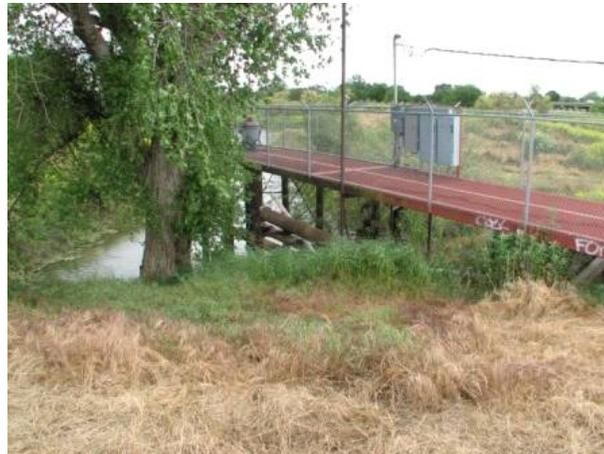
Levee Mile Report Line	20
Start Levee Mile	2.74
End Levee Mile	2.74
Location	Water Side
Category	Earthen Levee
Item	Encroachments
Irrigation intake near Maze Blvd.	
mkhashch_f_20130923_541.jpg

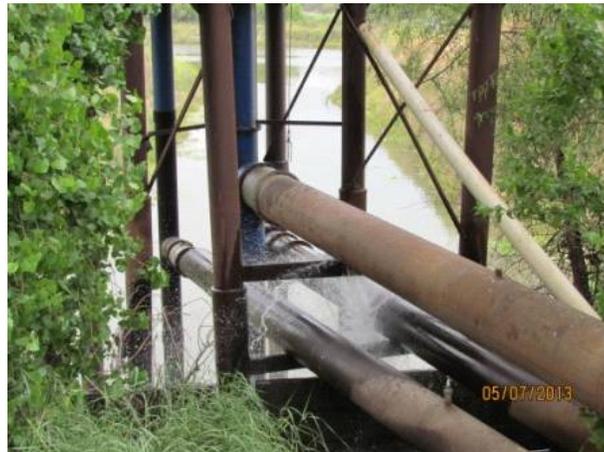
Levee Mile Report Line	20
Start Levee Mile	2.74
End Levee Mile	2.74
Location	Water Side
Category	Earthen Levee
Item	Encroachments
View of the pipe leaking during pumping. May cause erosion at waterside levee toe.	
mkhashch_f_20130923_542.JPG

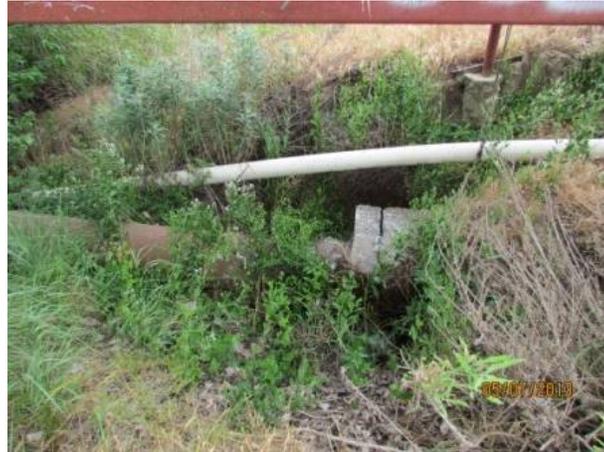
Levee Mile Report Line	20
Start Levee Mile	2.74
End Levee Mile	2.74
Location	Water Side
Category	Earthen Levee
Item	Encroachments
View of the leaking connection penetrating the levee. May cause erosion of the waterside levee slope.	
mkhashch_f_20130923_543.JPG

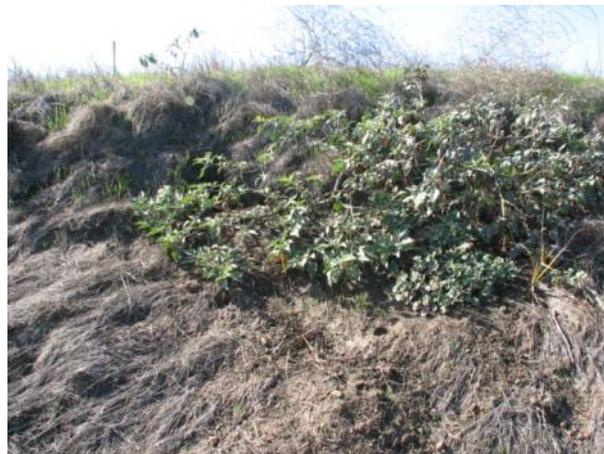
Levee Mile Report Line	21
Start Levee Mile	2.88
End Levee Mile	2.88
Location	Water Side
Category	Earthen Levee
Item	Animal Control
Rodent holes on levee slope hidden by vegetation.	
mkhashch_f_20130923_548.jpg

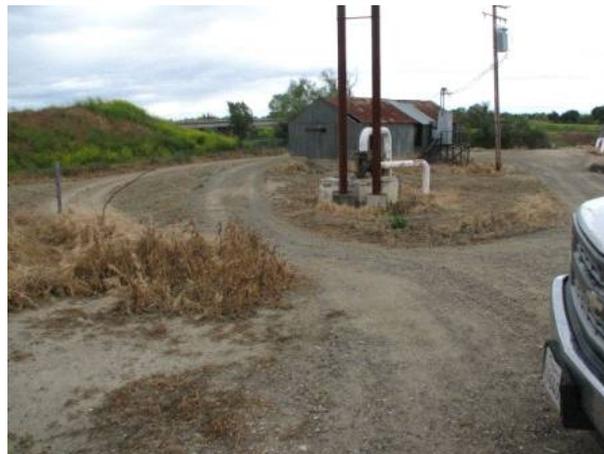
Levee Mile Report Line	22
Start Levee Mile	2.89
End Levee Mile	2.89
Location	Water Side
Category	Earthen Levee
Item	Encroachments
Risers on waterside berm and risers along road leading to levee indicate presence of pipe penetration.	
mkhashch_f_20130923_546.jpg

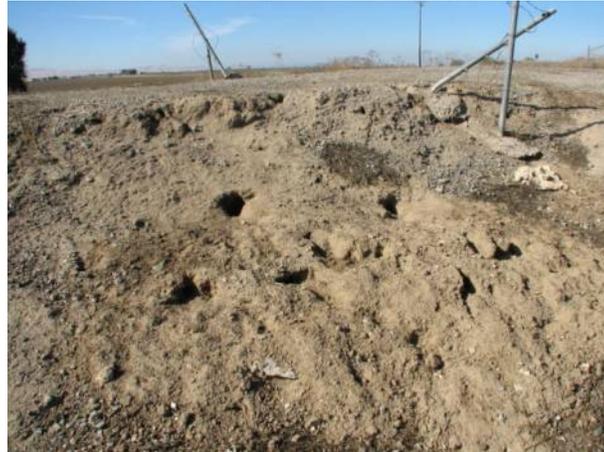
Levee Mile Report Line	23
Start Levee Mile	2.89
End Levee Mile	2.89
Location	Land Side
Category	Earthen Levee
Item	Animal Control
Rodent holes on levee slope.	
mkhashch_f_20130923_549.jpg

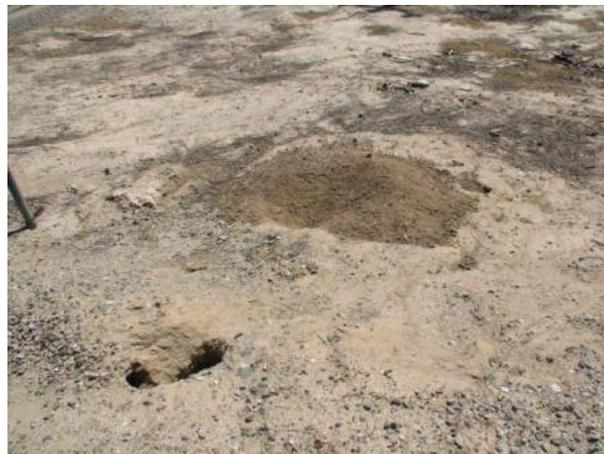
Levee Mile Report Line	23
Start Levee Mile	2.89
End Levee Mile	2.89
Location	Land Side
Category	Earthen Levee
Item	Animal Control
05/26/2011 Updated photo of animal control issue noted in Fall 2010 inspection, fresh rodent burrow present.	
mkhashch_f_20130923_550.jpg

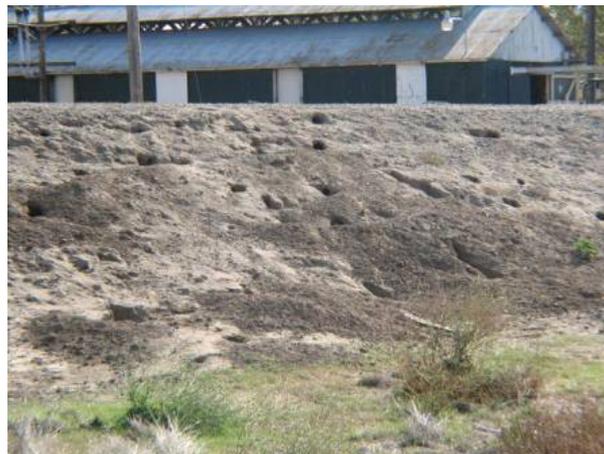
Levee Mile Report Line	23
Start Levee Mile	2.89
End Levee Mile	2.89
Location	Land Side
Category	Earthen Levee
Item	Animal Control
11/02/2011 Numerous burrows on levee slope.	
mkhashch_f_20130923_551.jpg

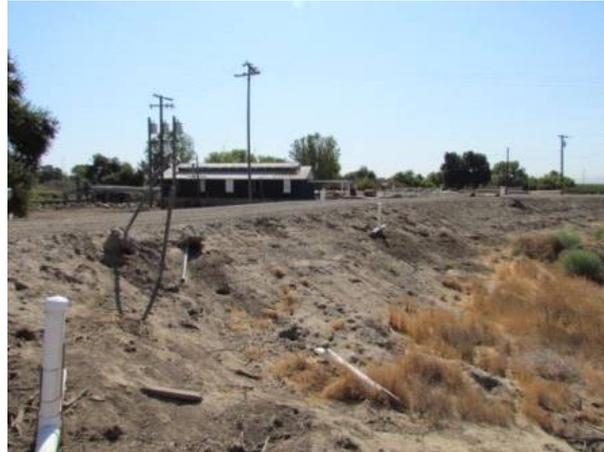
Levee Mile Report Line	23
Start Levee Mile	2.89
End Levee Mile	2.89
Location	Land Side
Category	Earthen Levee
Item	Animal Control
View of numerous rodent holes with bait stations present. 09/25/2012	
mkhashch_f_20130923_552.JPG

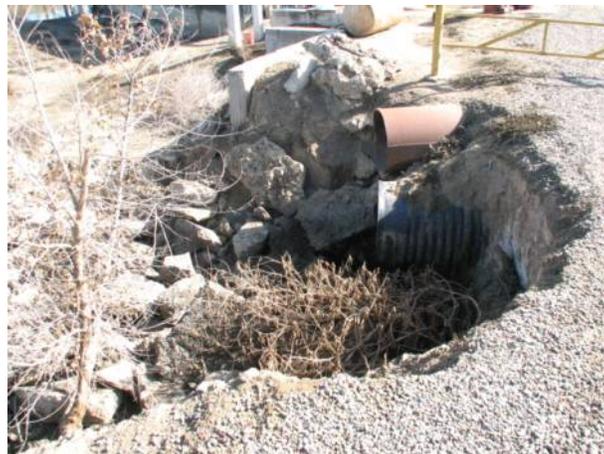
Levee Mile Report Line	24
Start Levee Mile	2.91
End Levee Mile	2.91
Location	Water Side
Category	Earthen Levee
Item	Erosion / Bank Caving
Levee slope is being eroded at this location. Repair needed to preserve access road.	
mkhashch_f_20130923_553.jpg

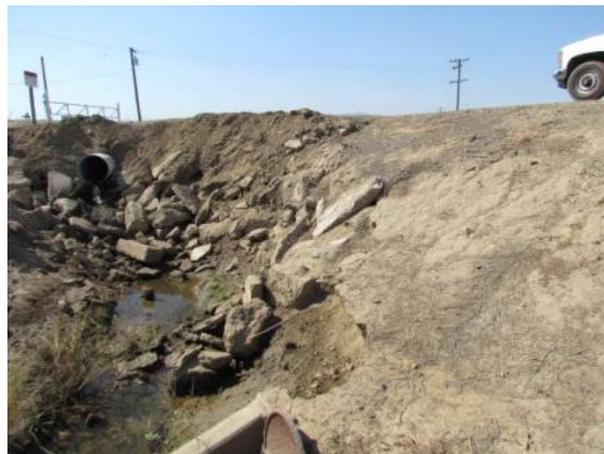
Levee Mile Report Line	24
Start Levee Mile	2.91
End Levee Mile	2.91
Location	Water Side
Category	Earthen Levee
Item	Erosion / Bank Caving
View of repaired site, but it appears that erosion is still occurring. 09/25/2012	
mkhashch_f_20130923_554.JPG

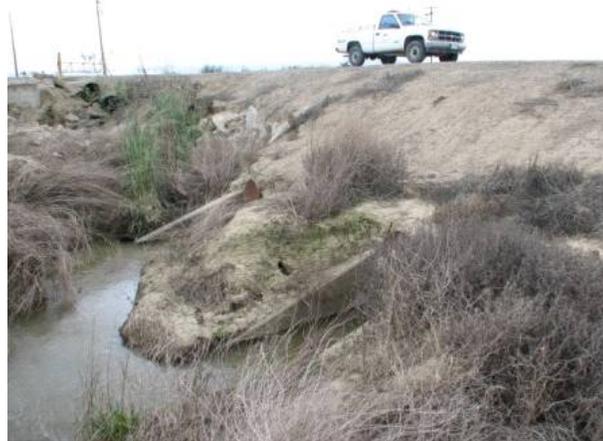
Levee Mile Report Line	25
Start Levee Mile	2.91
End Levee Mile	2.91
Location	Water Side
Category	Earthen Levee
Item	Encroachments

Drainage discharge to San Joaquin River.

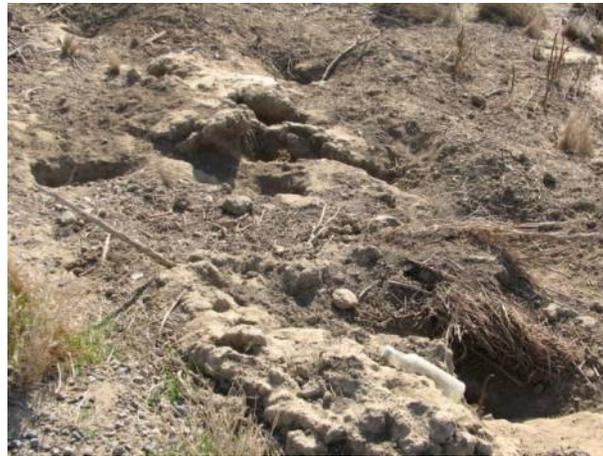
Levee Mile Report Line	27
Start Levee Mile	3.02
End Levee Mile	3.20
Location	Land Side
Category	Earthen Levee
Item	Animal Control

11/02/2011 Numerous burrows present, some already caving in, others are active.

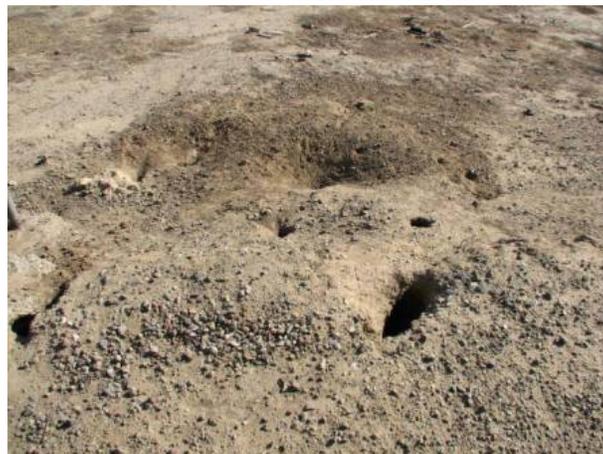
Levee Mile Report Line	27
Start Levee Mile	3.02
End Levee Mile	3.20
Location	Land Side
Category	Earthen Levee
Item	Animal Control

11/02/2011 Many active burrows present.

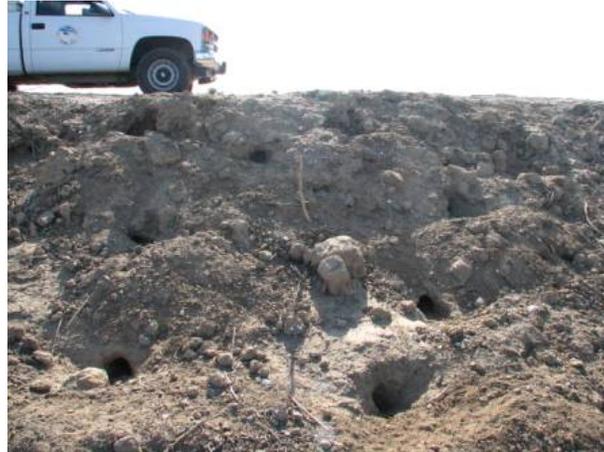
Levee Mile Report Line	27
Start Levee Mile	3.02
End Levee Mile	3.20
Location	Land Side
Category	Earthen Levee
Item	Animal Control
11/02/2011 Many burrows present throughout the levee slope.	
mkhashch_f_20130923_536.jpg

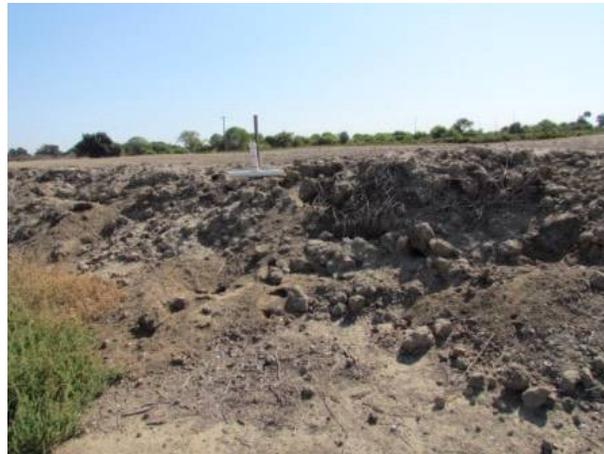
Levee Mile Report Line	27
Start Levee Mile	3.02
End Levee Mile	3.20
Location	Land Side
Category	Earthen Levee
Item	Animal Control
View of the many rodent holes on landside slope. 09/25/2012	
mkhashch_f_20130923_537.JPG

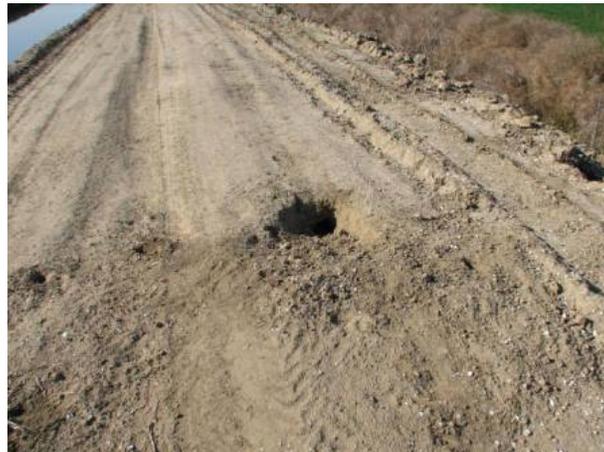
Levee Mile Report Line	28
Start Levee Mile	3.11
End Levee Mile	3.11
Location	Crown
Category	Earthen Levee
Item	Animal Control
11/02/2011 Large burrow in crown.	
mkhashch_f_20130923_538.jpg

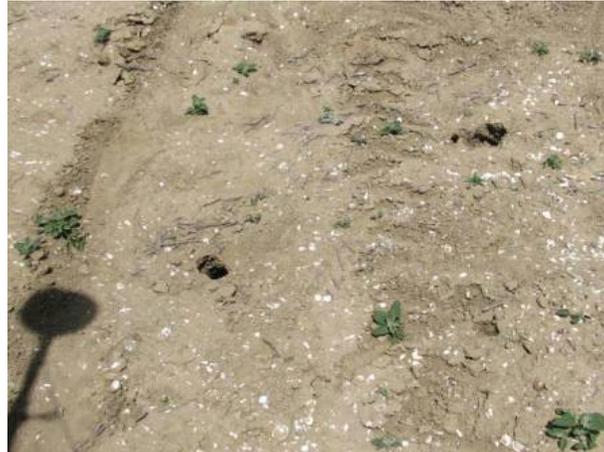
Levee Mile Report Line	28
Start Levee Mile	3.11
End Levee Mile	3.11
Location	Crown
Category	Earthen Levee
Item	Animal Control
05/02/2012 Rodent holes in the levee crown.	
mkhashch_f_20130923_539.jpg

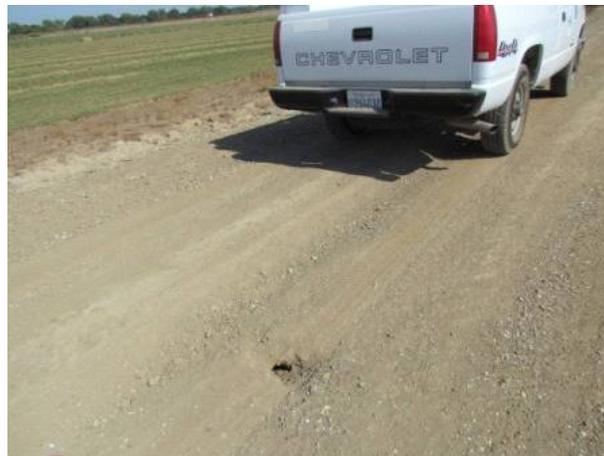
Levee Mile Report Line	28
Start Levee Mile	3.11
End Levee Mile	3.11
Location	Crown
Category	Earthen Levee
Item	Animal Control
View of the rodent hole in the levee crown. Smaller holes were covered due to crown regrading. 09/25/2012	
mkhashch_f_20130923_540.JPG

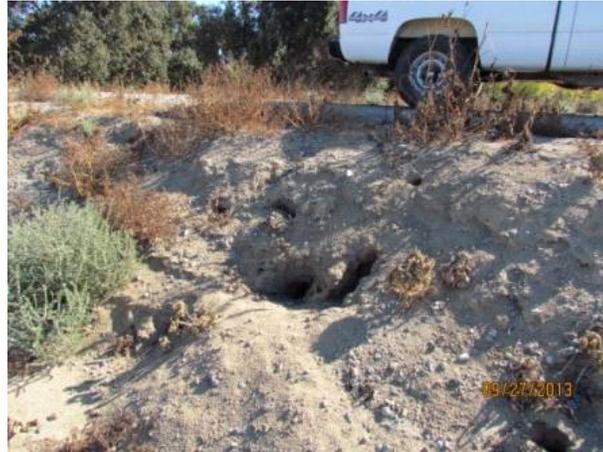
Levee Mile Report Line	2
Start Levee Mile	0.23
End Levee Mile	0.23
Location	Water Side
Category	Earthen Levee
Item	Animal Control
View of the rodent burrows on waterside levee slope.	
mkhashch_f_20130930_653.JPG
